NASA CR 72534

CdS SOLAR CELL DEVELOPMENT

CLEVITE CORPORATION

FINAL REPORT

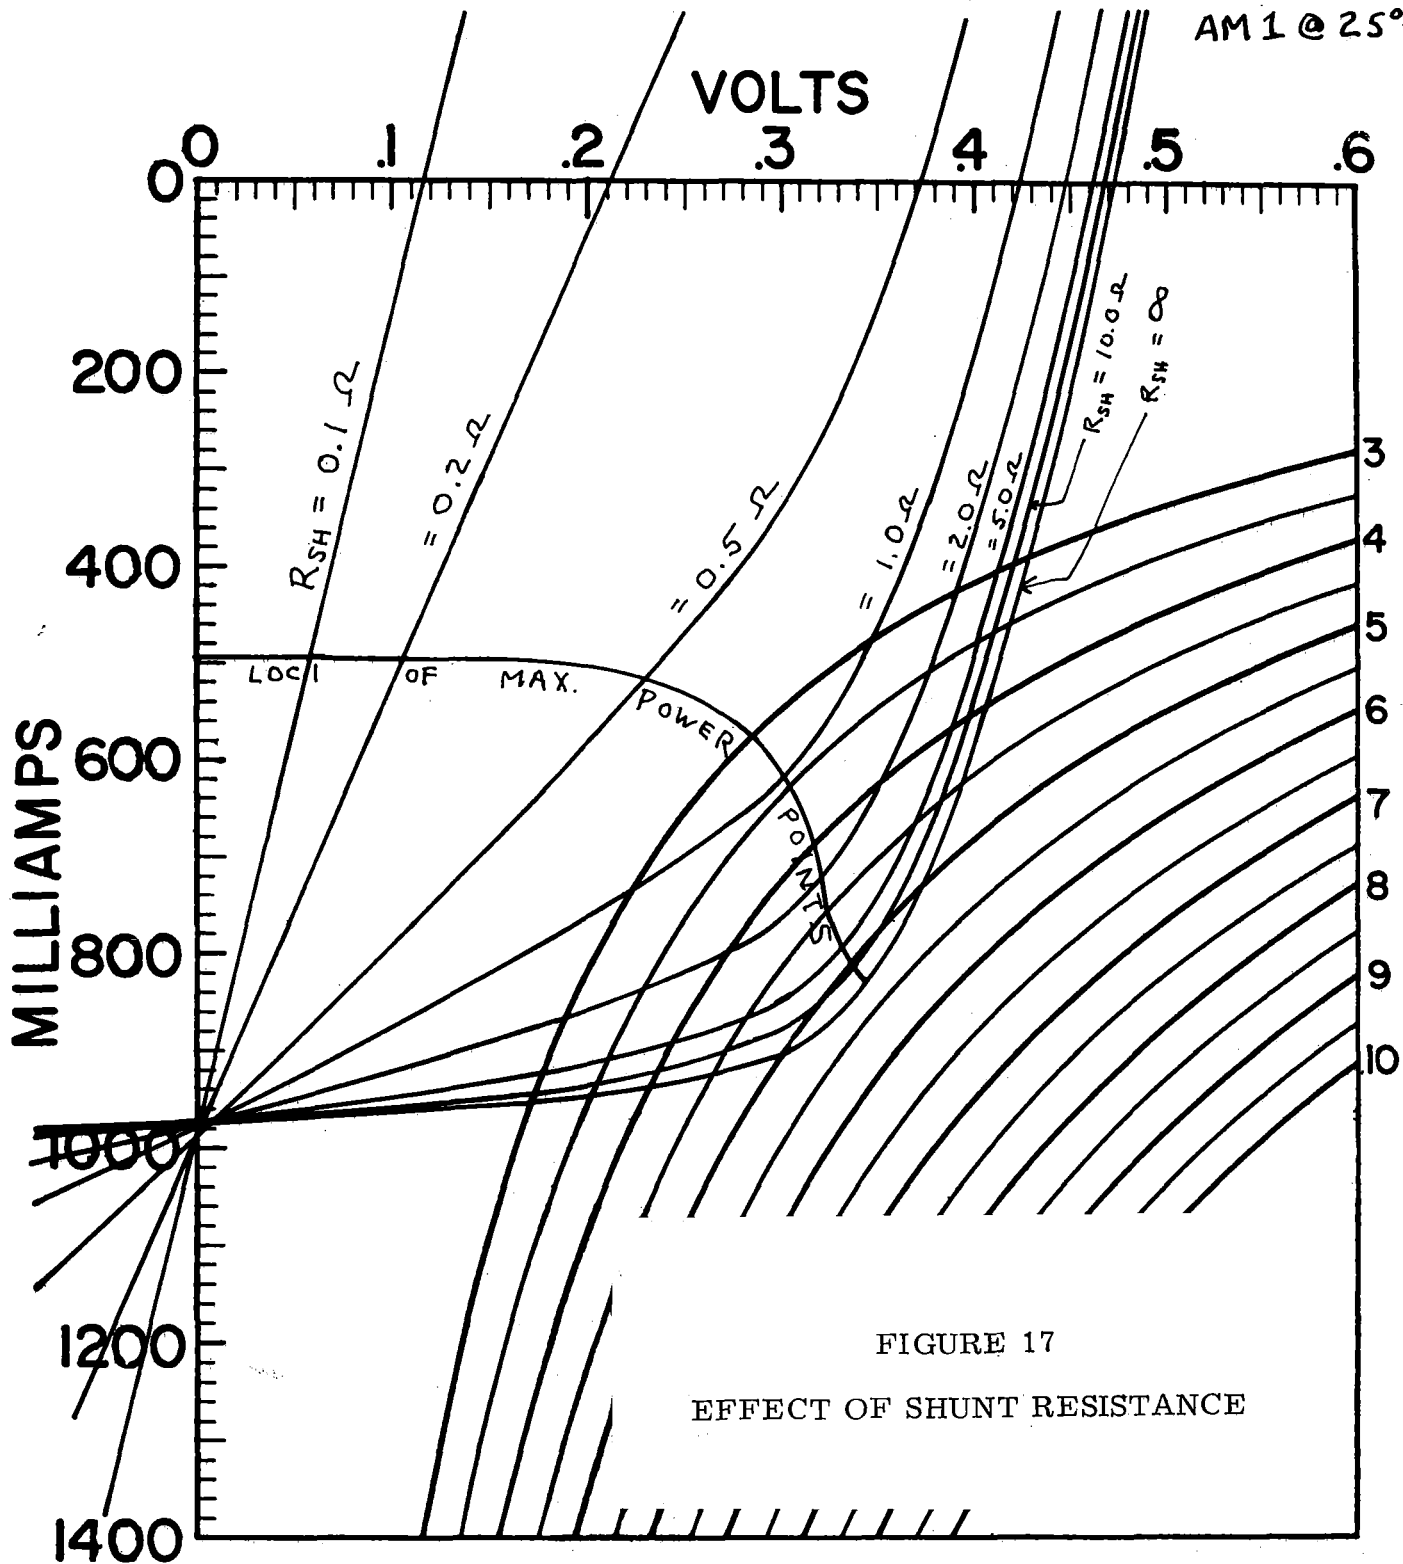
FIGURE 17

EFFECT OF SHUNT RESISTANCE

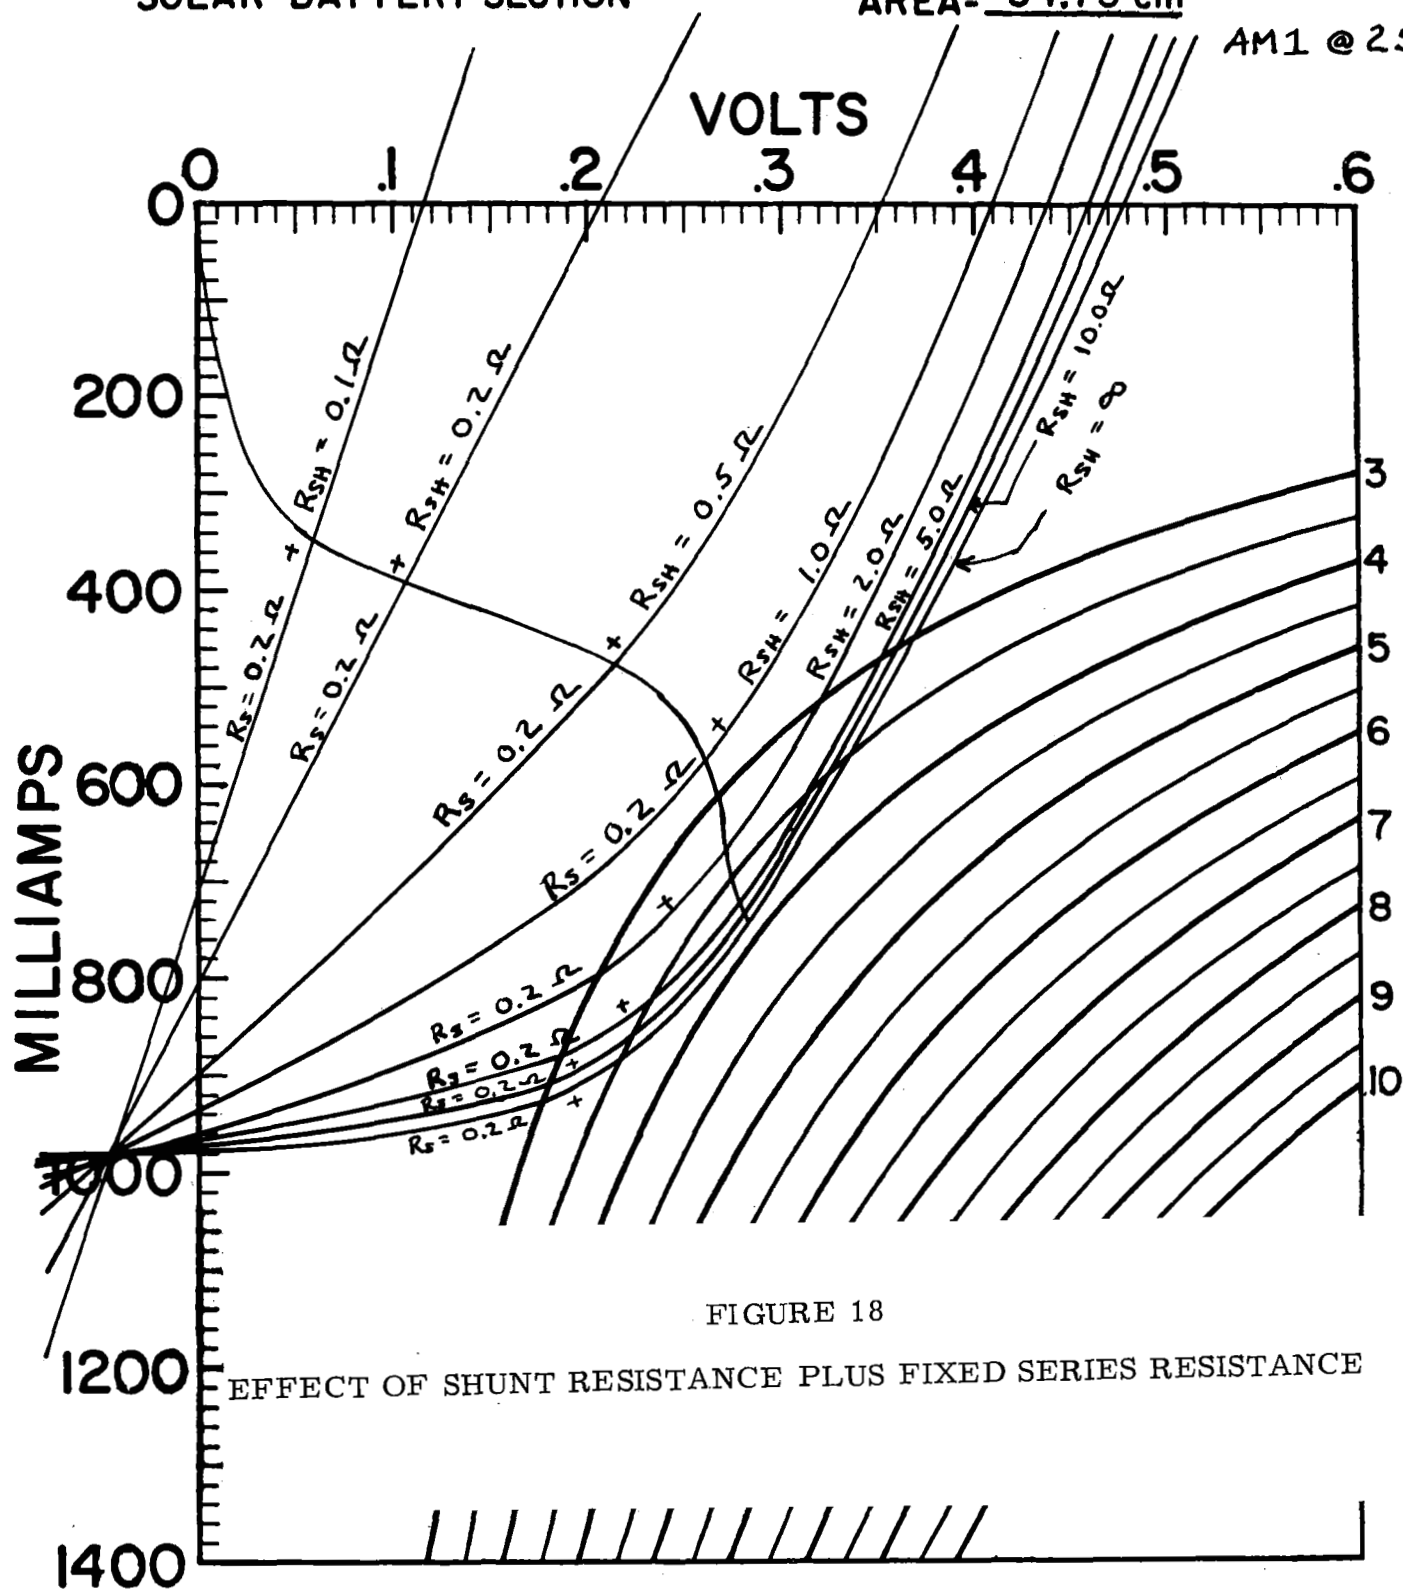
FIGURE 18

EFFECT OF SHUNT RESISTANCE PLUS FIXED SERIES RESISTANCE
